SAFETY ALERT

Incident Involving Powered Rope Access Equipment

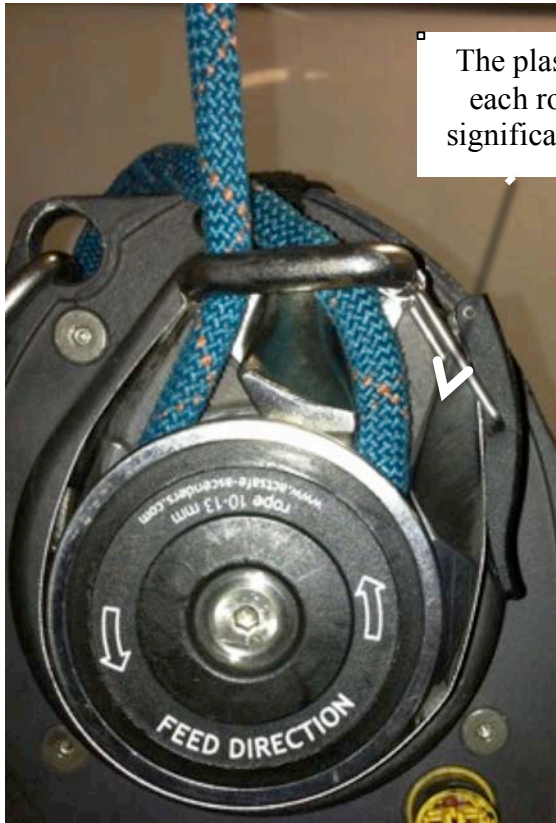
The predominant contributing factor for this incident was that the powered ascender was fitted with a superseded rope cover. The design of the rope cover was changed in 2009, and this particular machine was not modified. The manufacturer took the correct actions and sent a safety alert to all of their importers and distributors, however the independent distributor at the time did not pass on the information and the replacement part to all users. The manufacturer also offered the replacement part at no cost to the end user.

1. Abnormal spooling of the rope out between the rope grab and the rope guide.
 - The powered ascender had a superseded rope cover fitted.
 - It is assumed that the tail of rope exiting the device was blocked, causing the rope to spool abnormally.

Superseded rope cover

Figure 2. Superseded rope cover.

The equipment manufacturer (ActSafe) distributed a safety notice to all distributors in 2009 notifying them of a number of safety measures that are required of end users. Included in this safety alert was the need to change out the rope cover to a new design. The replacement rope cover was offered to end users free of charge.

The safety notice was not effectively communicated within Australia; consequently the replacement rope covers were not supplied to all end users.

To Be Removed and Replaced

1. Notify end users of the incident details through this safety alert.
2. End users to inspect their equipment to identify if their unit has a superseded rope cover. This applies to ACC 1 models manufactured during, or prior to 2009.
3. If a unit is found to have a superseded rope cover, it must be immediately removed from service and the user contact the Manufacturer.
4. All devices to be sent to the authorised service agent at least annually for inspection.
5. Users to only insert the emergency descent pin when necessary for emergency descent and to remove the pin at all other times. The emergency descent manually disengages the brake, and will function even when the electrical system is isolated.

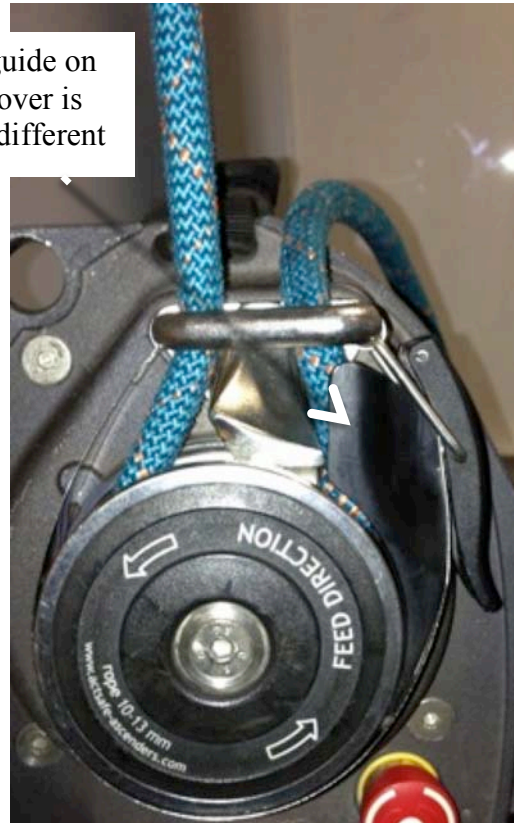
Figure 3. Replacement / current design rope cover
