SAFETY ALERT

Incident Involving Powered Rope Access Equipment

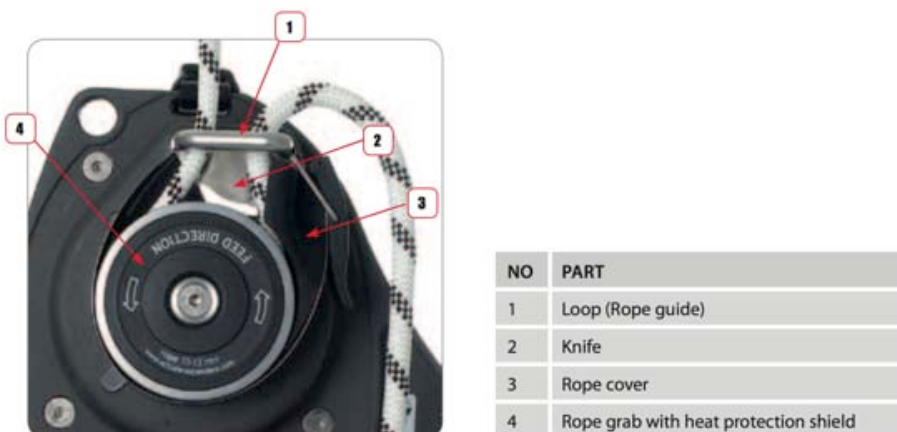
The predominant contributing factor for this incident was that the powered ascender was fitted with a superseded rope cover. The design of the rope cover was changed in 2009, and this particular machine was not modified. The manufacturer took the correct actions and sent a safety alert to all of their importers and distributors, however the independent distributor at the time did not pass on the information and the replacement part to all users. The manufacturer also offered the replacement part at no cost to the end user.

Figure 1. ActSafe ACC powered ascender drive system nomenclature of parts.

1. Notify end users of the incident details through this safety alert.
2. End users to inspect their equipment to identify if their unit has a superseded rope cover. This applies to ACC 1 models manufactured during, or prior to 2009.
3. If a unit is found to have a superseded rope cover, it must be immediately removed from service and the user contact the Manufacturer.
4. All devices to be sent to the authorised service agent at least annually for inspection.
5. Users to only insert the emergency descent pin when necessary for emergency descent and to remove the pin at all other times. The emergency descent manually disengages the brake, and will function even when the electrical system is isolated.
